BIOLOGICAL ASSESSMENT

River Management Alternatives for the Rio Grande Canalization Project

**UNITED STATES SECTION,
INTERNATIONAL BOUNDARY AND WATER COMMISSION**

January 2004

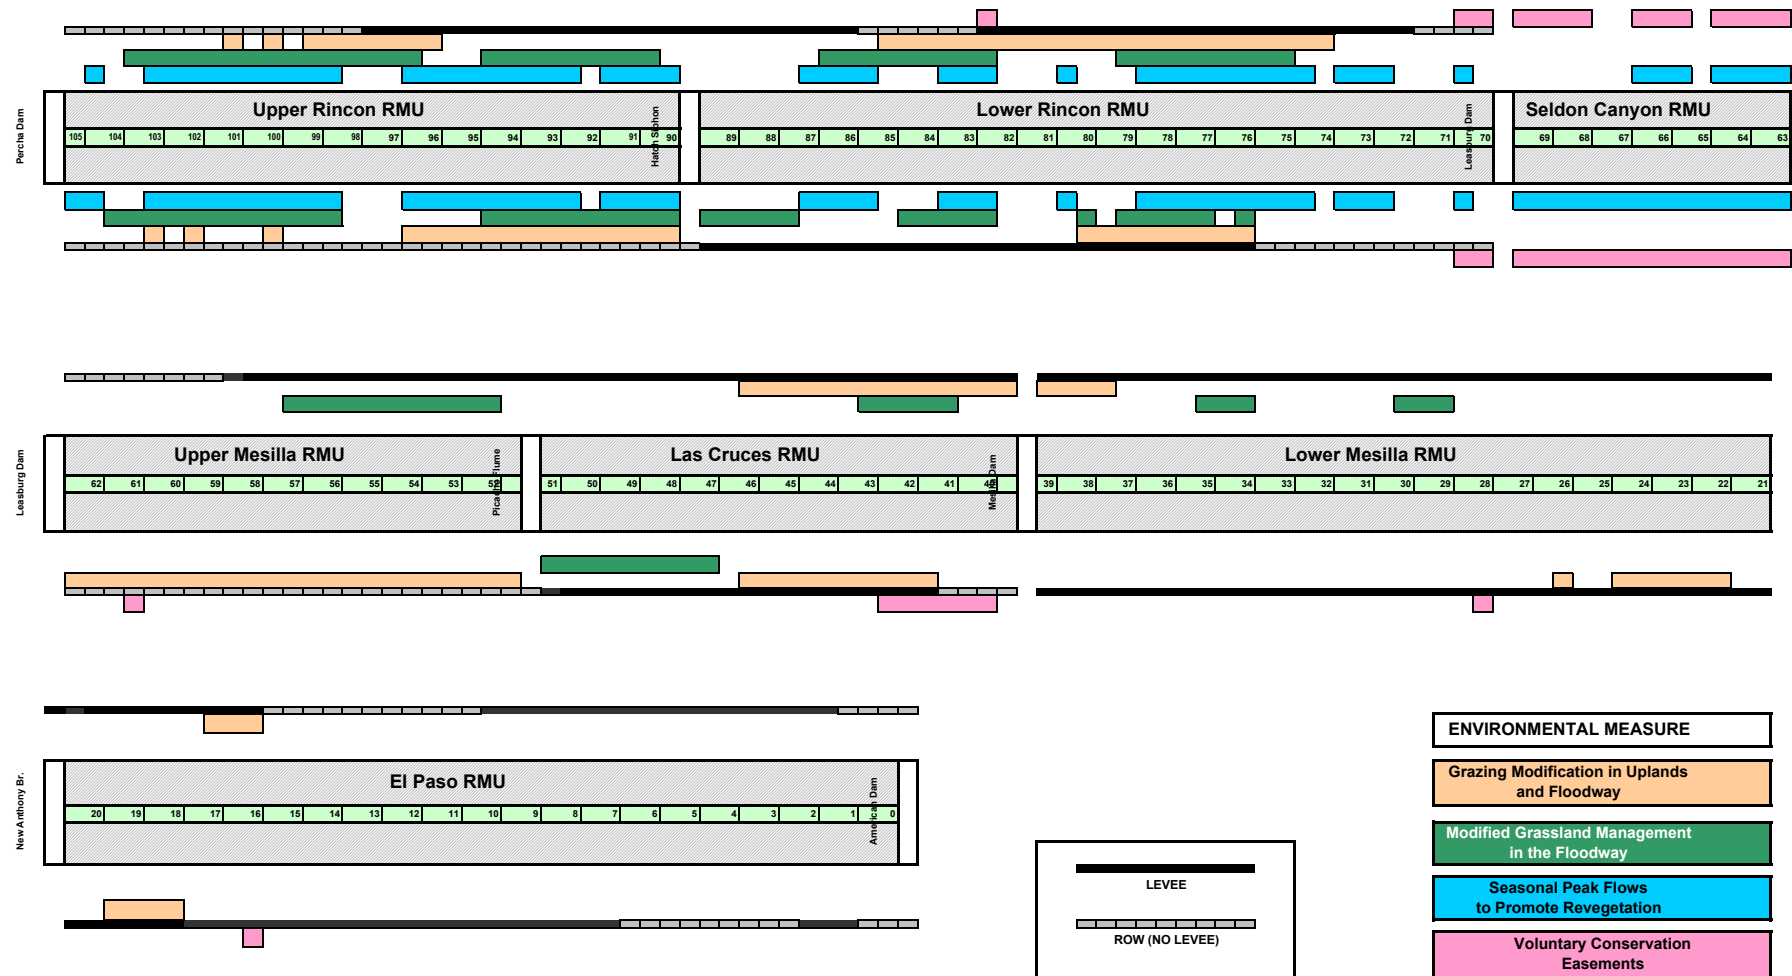
Figure 2-2 Environmental Measures to be Implemented as Linear Projects

The Targeted River Restoration Alternative includes linear projects associated with four types of environmental measures, modified grazing leases, modified grassland management, seasonal peak flows, and voluntary conservation easements.

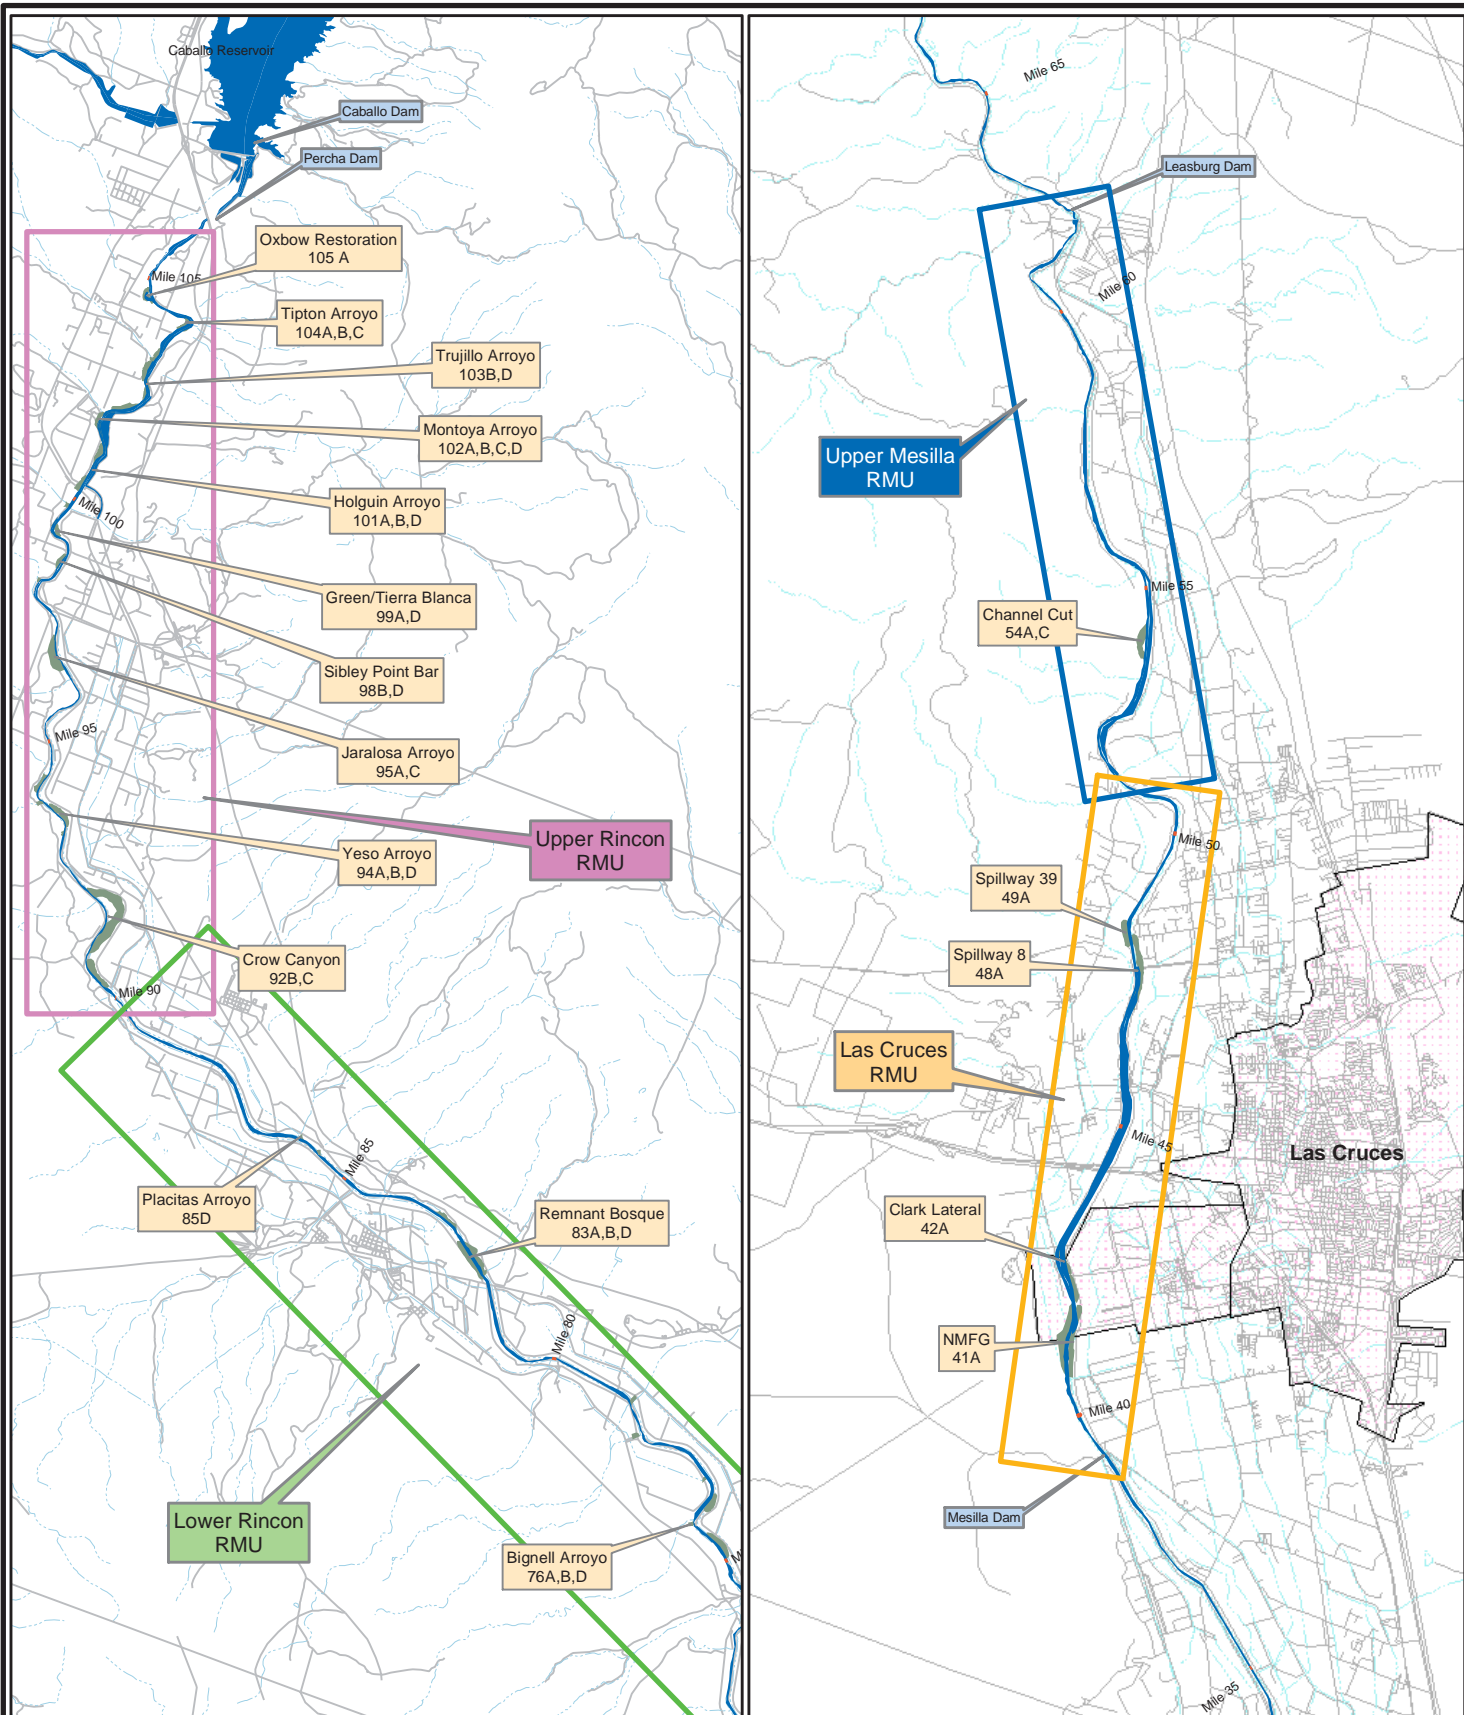
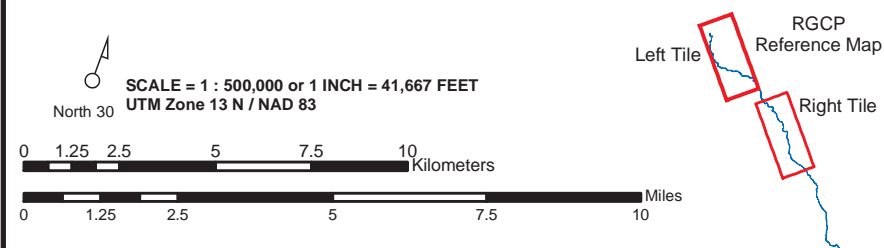
Figure 2-3 Distribution of Point Projects in the Rincon and Mesilla Valleys

RIVER MILE ID			INTEGRATED USIBWC LAND MANAGEMENT ALTERNATIVE		TARGETED RIVER RESTORATION ALTERNATIVE		
			MEASURE A: NATIVE VEGETATION PLANTING	MEASURE B: STREAM BANK SHAVEDOWNS	MEASURE A: NATIVE VEGETATION PLANTING	MEASURE C: OPEN FORMER MEANDERS	MEASURE D: MODIFY DREDGING AT ARROYOS
101	Holguin Arroyo	Project Acres	101A 6.0	101B 12.5	101A 6.0		101D 0.16
99	Green Tierra	Project Acres	99A 5.1		99A 5.1		99D 0.27
98	Sibley Point Bar	Project Acres		98B 4.1			98D 0.27
97	Jaralosa Arroyo	Project Acres				97C 28.0	97D 0.44
95	Jaralosa South	Project Acres	95A 5.1			95C 5.1	
94	Yeso Arroyo	Project Acres	94A 11.5	94B 3.9	94A 11.5		94D 0.44
92	Crow Canyon	Project Acres		92B 17.9		92C 84.6	
85	Placitas Arroyo	Project Acres					85D 0.52
83	Remnant Bosque	Project Acres	83A 16.2	83B 17.9	83A 16.2		83D 0.3
78	Rincon/Reed Arroyo	Project Acres					78D 2.74
76	Bignell Arroyo	Project Acres	76A 10.3	76B 16.3	76A 10.3		76D 0.52

54	Channel Cut	Project Acres	54A 19.6			54C 19.6	
49	Spillway No. 39	Project Acres	49A 15.9		49A 15.9		
48	Spillway No. 8	Project Acres	48A 34.6		48A 34.6		
42	Clark Lateral	Project Acres	42A 15.4		42A 15.4		
41	Picacho and NMGF	Project Acres	41A 71.3		41A 71.3		
Total Acreage:			223	127	189	147	6.8

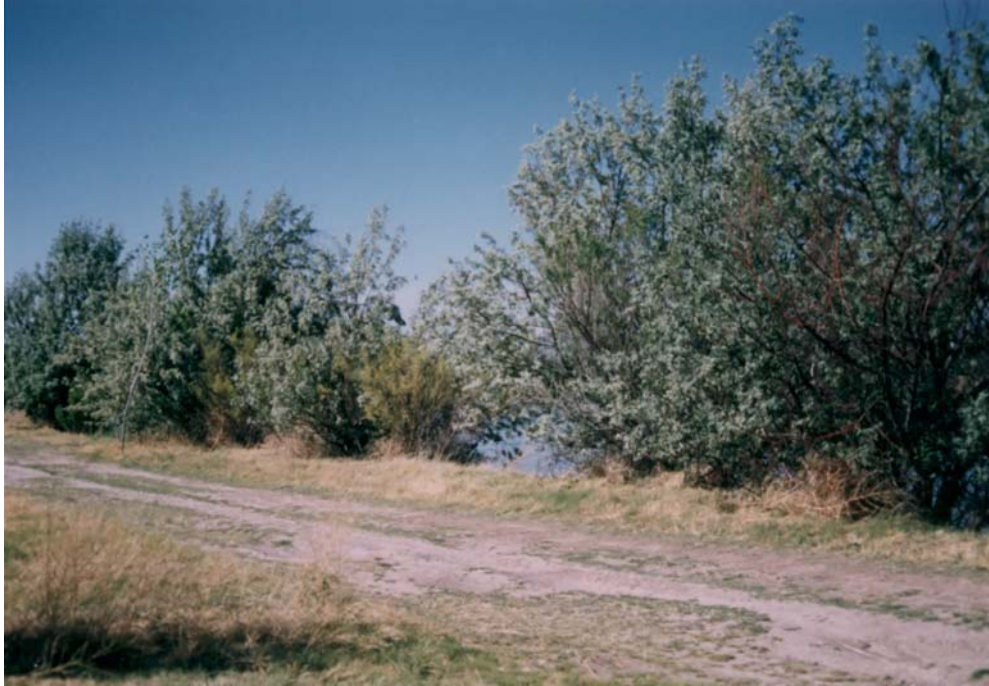
DALC2: Russian olive dominates river bank with few salt cedar intermixed. Cottonwood pole plantings are located in the center of the flood plain. Flood plain is dominated by bermudagrass.

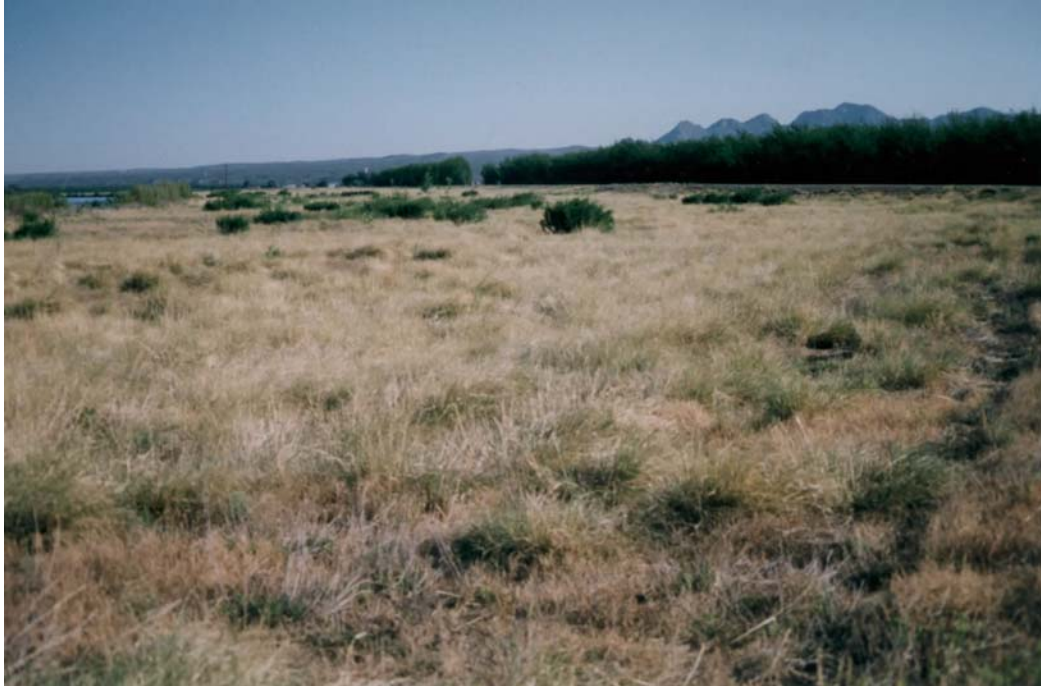
DALC3: Wide flood plain dominated by sand dropseed (*Sporobolus cryptandrus*). River bank is lined by a narrow band of willows (<5m wide).

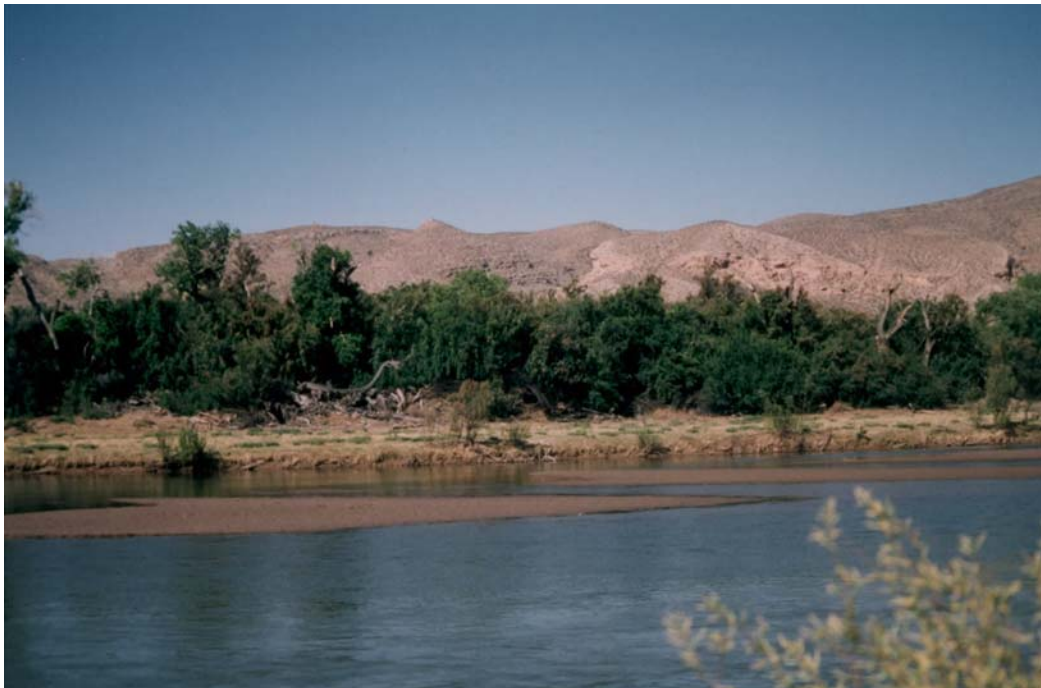
LDA2: West side of river is dominated by salt cedar. Occasional cottonwoods occur. Many snags providing good habitat for cavity dwellers. This site has been severely overgrazed.

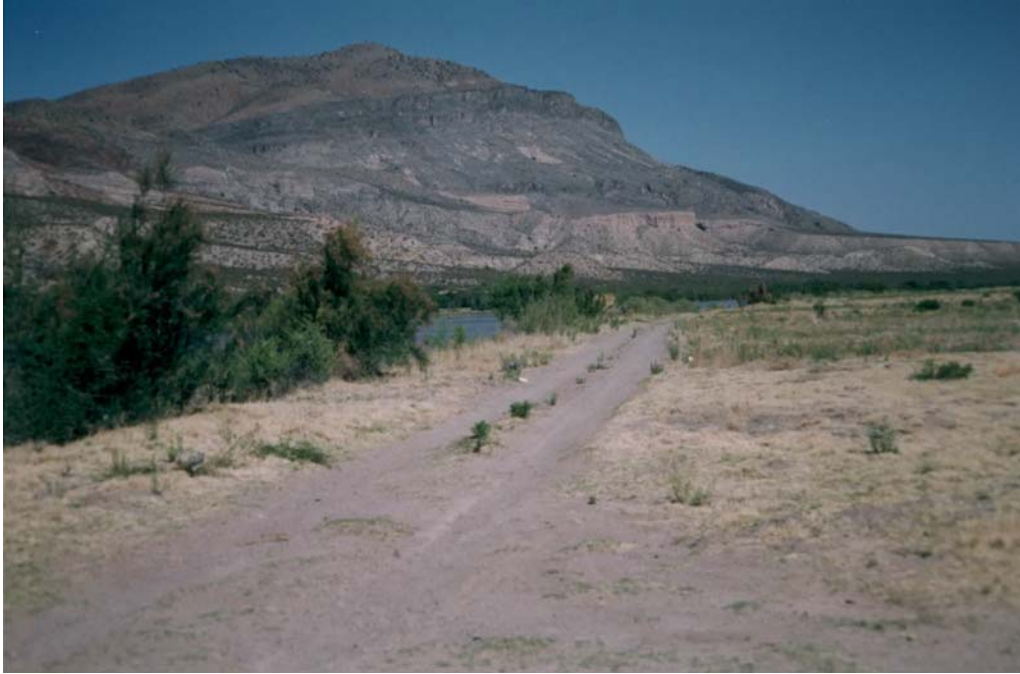
SCL1: Salt cedar lining the river bank. Bermudagrass dominates the flood plain.
Relatively wide flood plain.

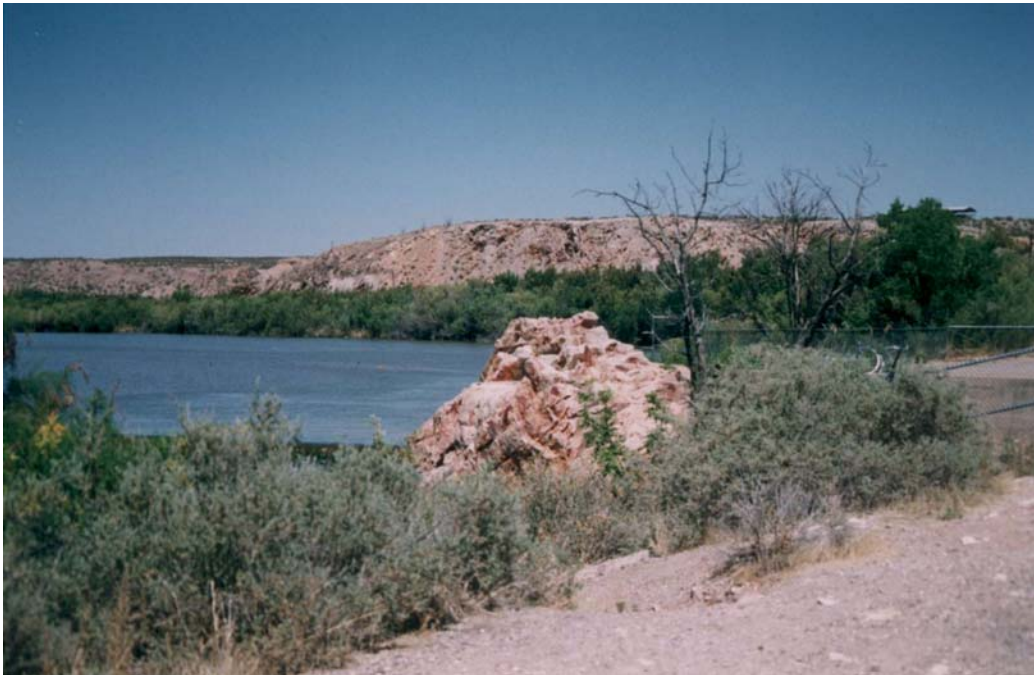
Leasburg Dam: Very dense salt cedar community with an occasional cottonwood. Many cottonwood snags.

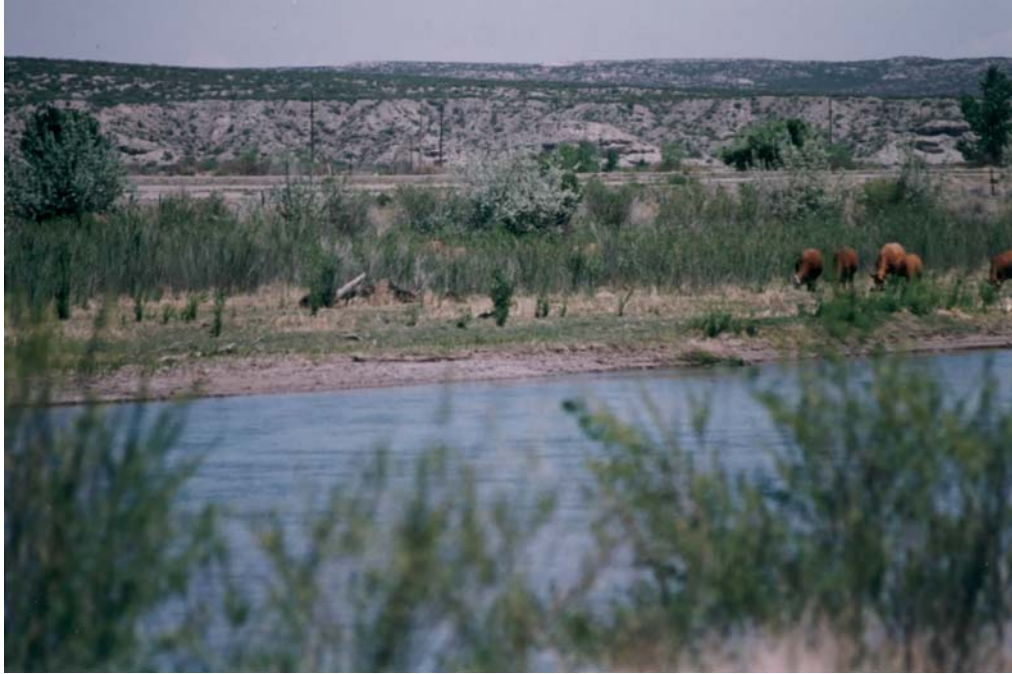
RSA2: Severely overgrazed area that is dominated by salt cedar. Little vegetation to stabilize river bank.

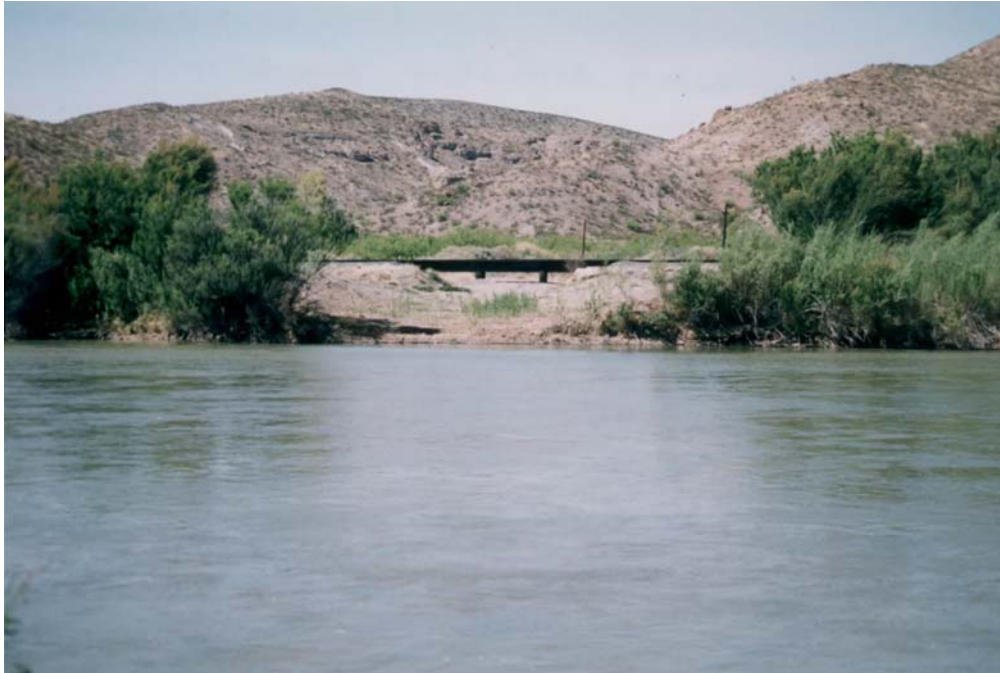
Arroyo: Arroyo confluence with railroad right-of-way. Salt cedar and willows line the river bank.

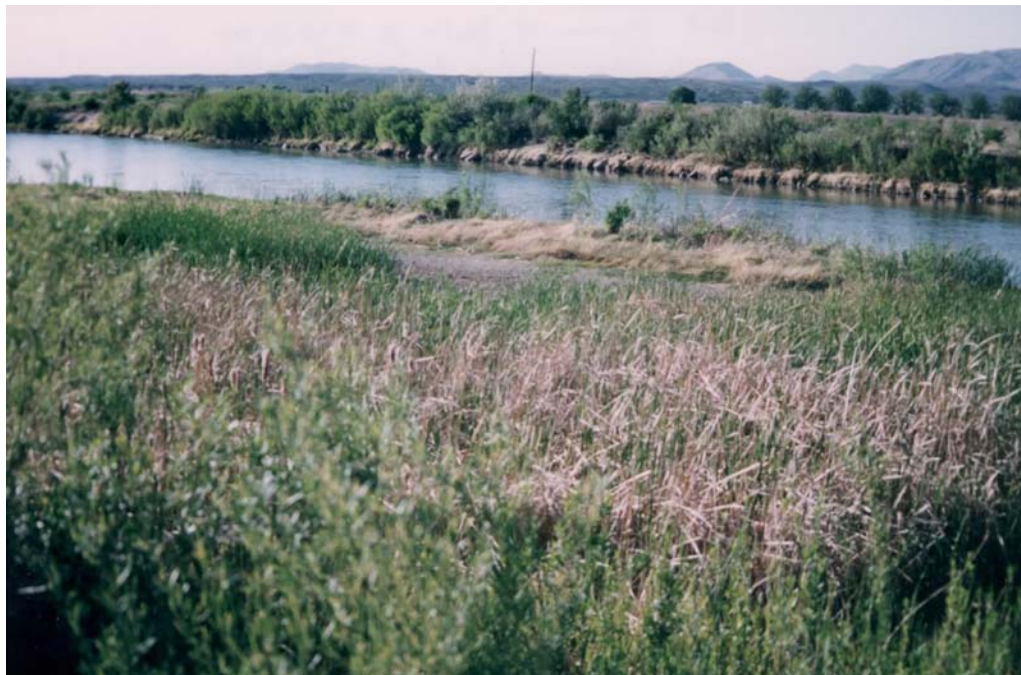
HR2: Wetlands habitat with volunteer cottonwoods. Vegetated sand bar lines the river.

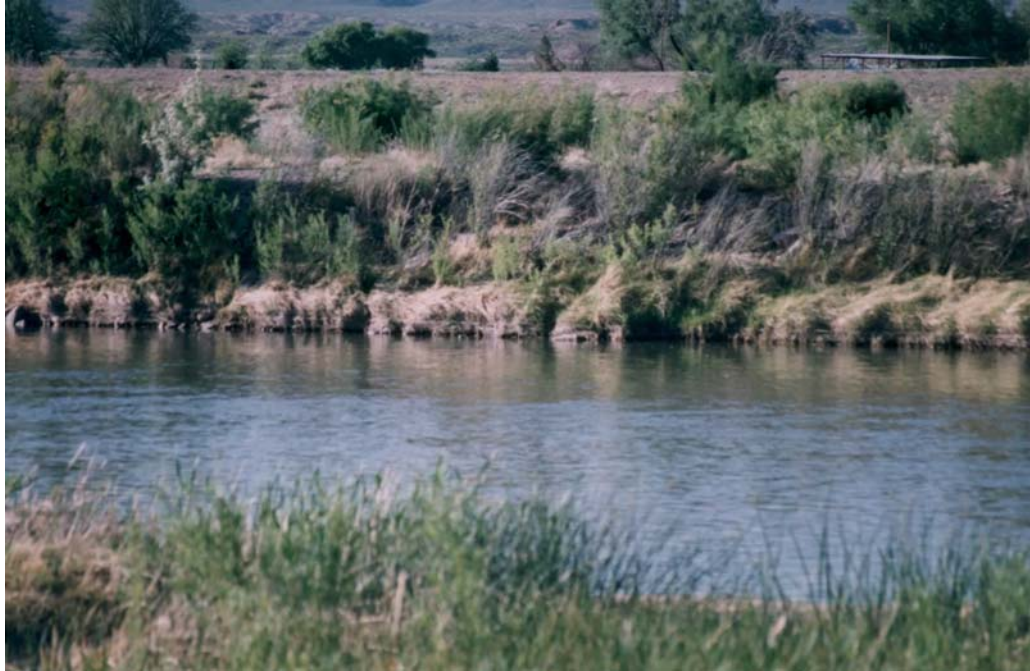
H1: Narrow flood plain that is dominated by salt cedar. Willow and alkali sacaton line the river.

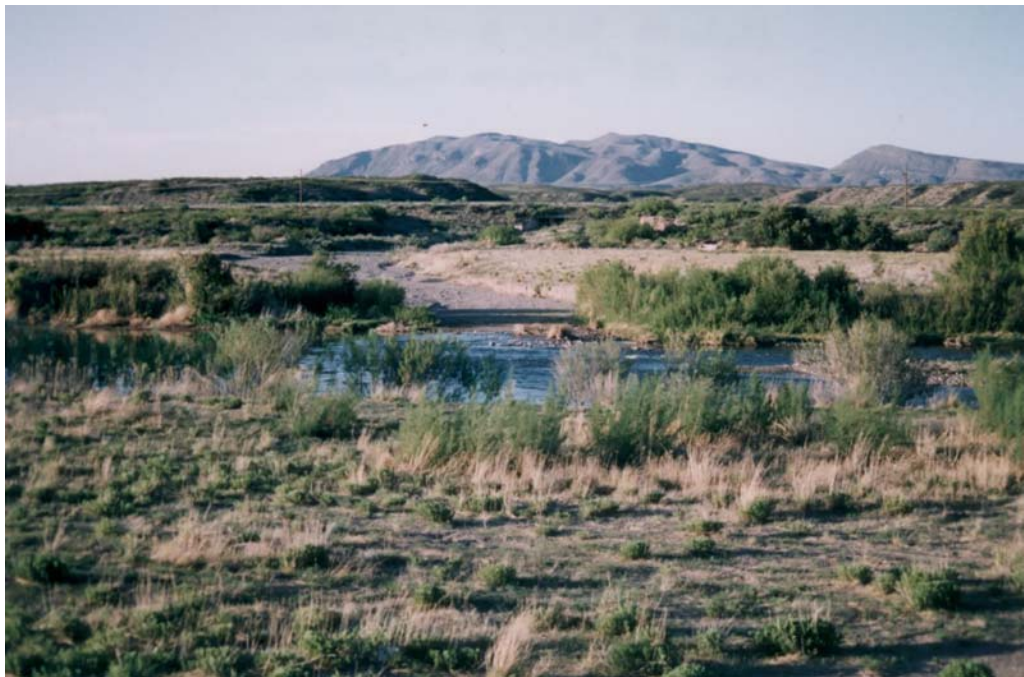
H1: An arroyo confluence with the river. Surrounding flood plain dominated by salt cedar and bermudagrass. Flood plain on west side of river consists of mostly bare ground.

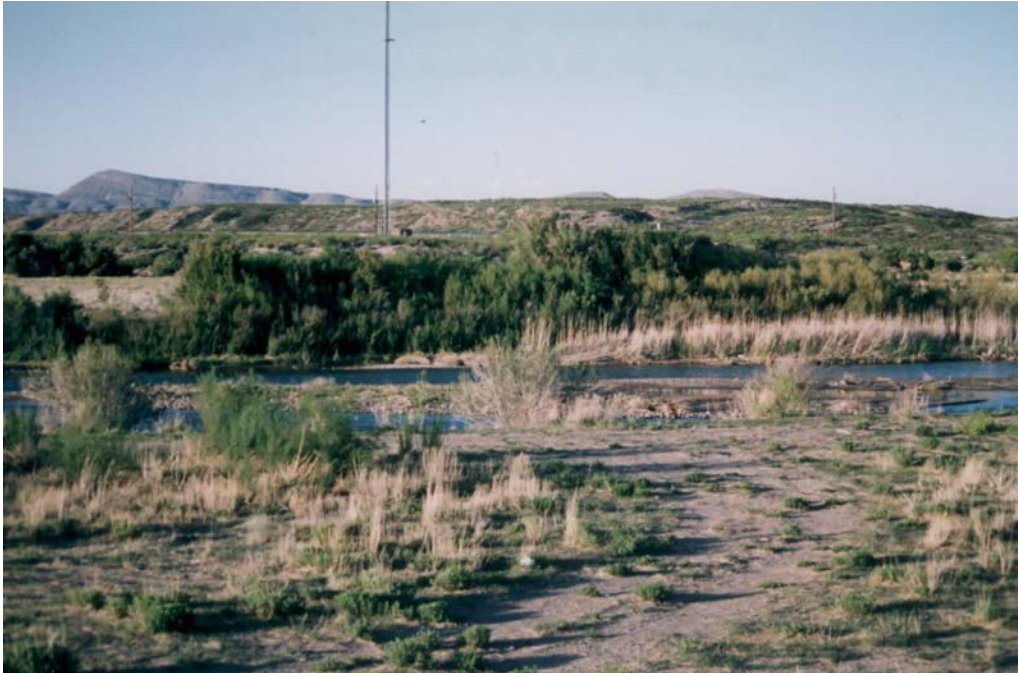
H2: Well vegetated island wetland on sand bar in the middle of the channel.

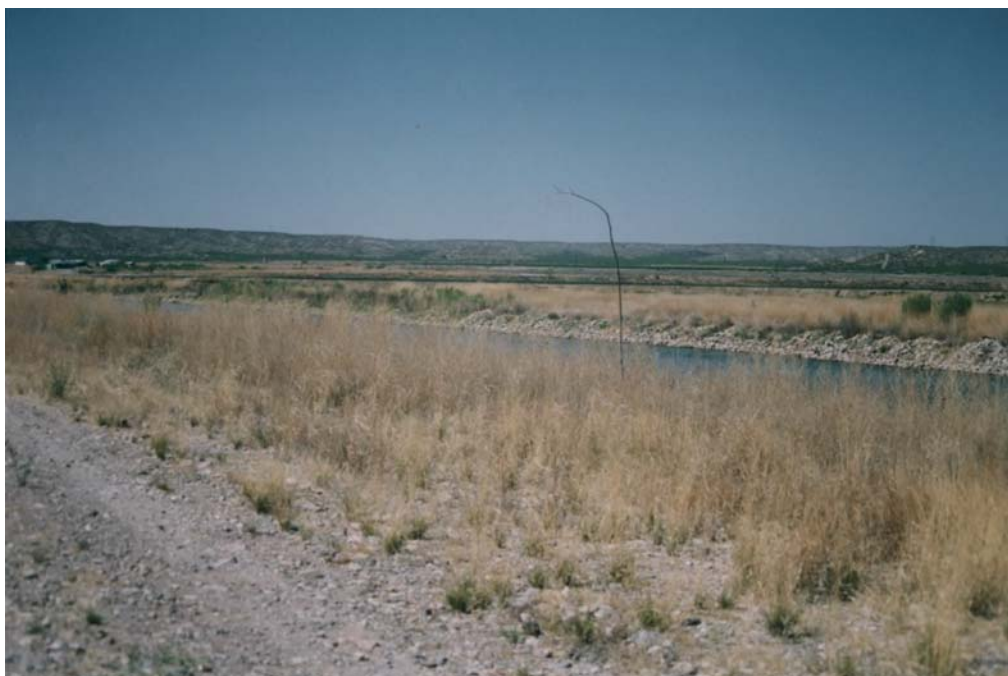
G1: Armored river bank. Wide flood plain dominated by sand dropseed. Several dead pole plantings.

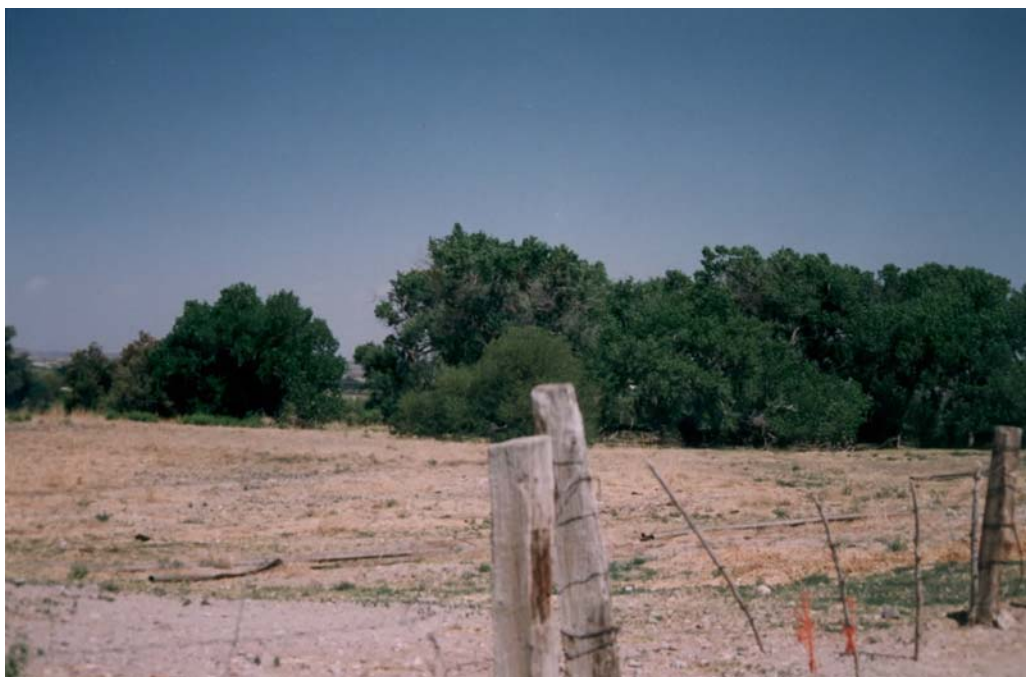
G3: Green ash and cottonwoods dominate the center of the flood plain. The area surrounding the trees has been severely overgrazed.
